FLOOD PLAIN INFORMATION
CONNECTICUT RIVER, WEST RIVER
AND
WHETSTONE BROOK

BRATTLEBORO
VERMONT

PREPARED FOR
THE TOWN OF BRATTLEBORO
BY
DEPARTMENT OF THE ARMY
NEW ENGLAND DIVISION CORPS OF ENGINEERS
WALTHAM, MASS.

JANUARY 1972

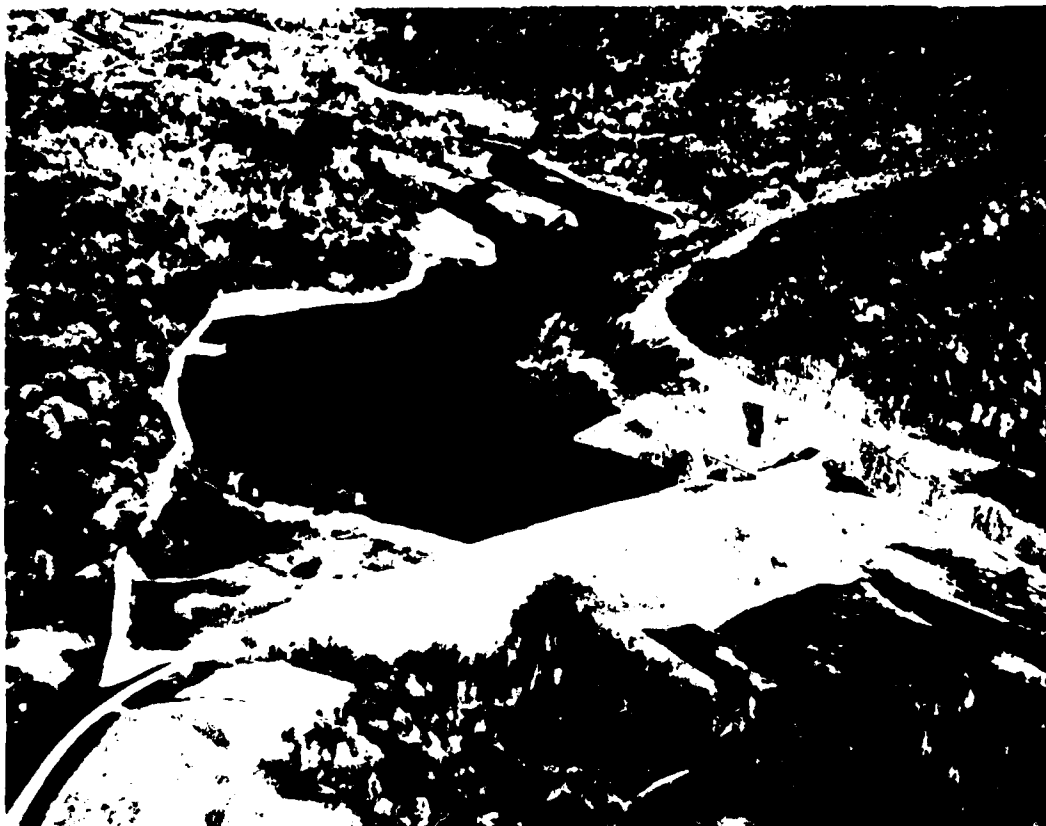
Townshend Dam and Reservoir

The project features a rolled-earth and rockfill dam, 133 feet high and 1,700 feet long; outlet works founded on bedrock under the dam; and a side channel spillway 439 feet long at the left abutment. The project was completed in June 1961.

full, a 730-acre pool would extend 4.5 miles upstream in Townshend and Jamaica. The project is operated as a unit in the comprehensive plan for flood protection in the Connecticut River basin and provides protection for downstream damage centers on the West and Connecticut Rivers. The project has had six significant storage operations since its completion, which have prevented damages of an estimated \$780,000. In a recurrence of the March 1936 basin flood of record, it would prevent damages of about \$8,498,000.

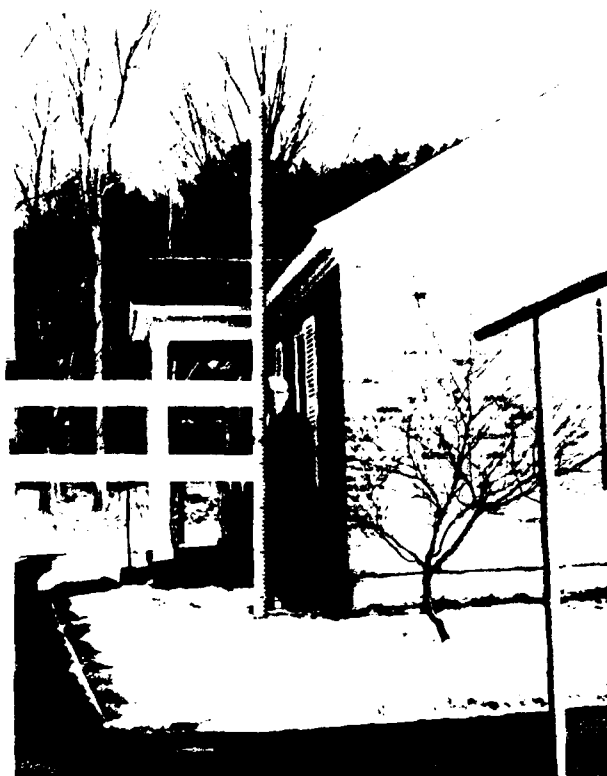
Flood Heights, upstream end of Melrose Terrace Housing Development for the Elderly, West Brattleboro.

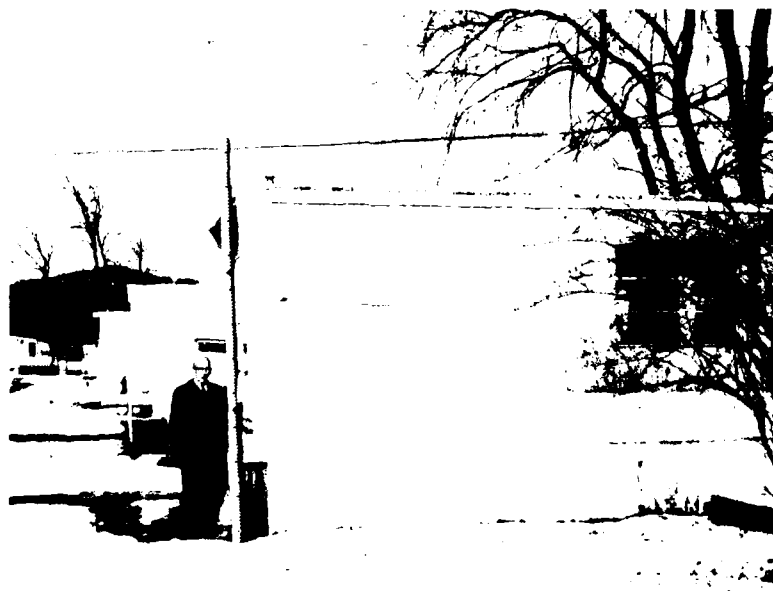
Flood Heights, mobile home in Glen Trailer Park, across Whetstone Brook from photograph above.

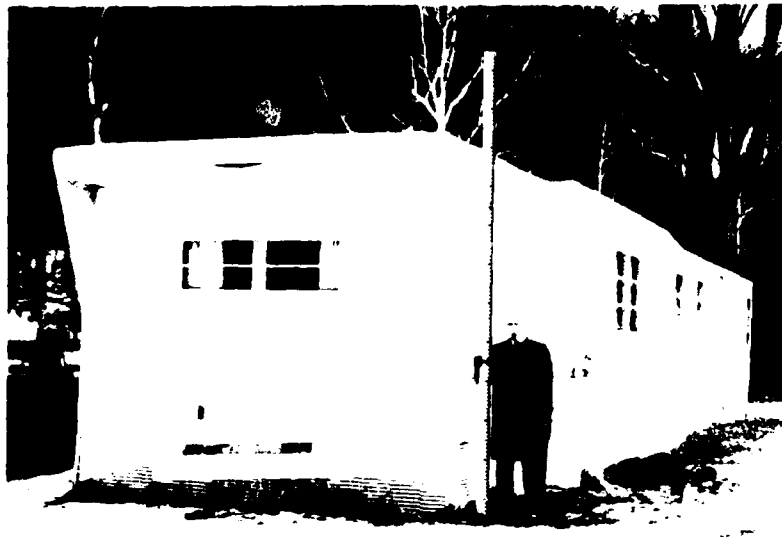
Flood Heights, mobile home in Mountain Home Trailer Park on left bank of Whetstone Brook opposite Country Kitchen, West Brattleboro.
